Notification

Date:	23-Apr-21
Category:	No internal incoming cables (Not complete wiring inside VSD).
Scope:	Electrical
Country:	Libya
Location:	ESP yard
Report #:	2021-0401
Severity:	Medium
AOSCO Rep:	Bambang Handoko

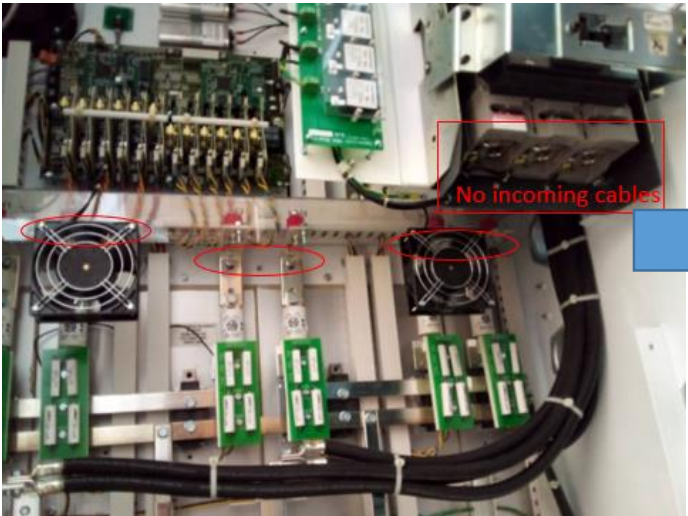
There are 4 VSD skids 400KVA with the configuration as follows: 400KVA Step Down Transformer – phase shifted 12 pulse operation PO:4505926933, 350-454KVA VSD, 12 pulse (but only has 1 breaker), PN:C544003049 and 400 KVA Step Up Transformer PO:45059269443.
Found that there were no incoming cables that should be available from the VSD main breaker to the VSD converter. It should have 12 cables.

- 4 units 400 KVA VSDs were reported in new condition since around 8 years purchased and no inspection was performed since they came.
